# **Statement of Need**

To replace failing church light fittings with modern eco-friendly LED units for church main worship area.

Whilst accessing the high-level roof space to also inspect and repair "fibreboard" inserts in church ceiling. Fault reported in 2018 Quinquennial report items 3.4.2 and 3.4.3.

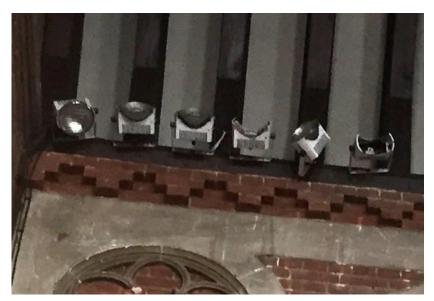
There are 85 Halogen 300w lighting units in the church worship space. These were fitted in 1986 and are increasingly failing. Lamps can be replaced, but the fittings are breaking and are no longer available for what is now an obsolete lamp.

*Existing lighting units. Those pointing upwards or without lamps are no longer working.*

A temporary replacement of some halogen lamps was performed in 2016, but these typically have a 5-year lifespan - so these are now expiring. There is therefore urgency to this project, since for example in the main nave, there are now only 4 working lamps instead of 20. Some areas of the church are very gloomy!

85 Halogen lamps to be replaced with 62 single lamp LED lighting units. A lower number since some areas were previously unnecessarily over-lit.

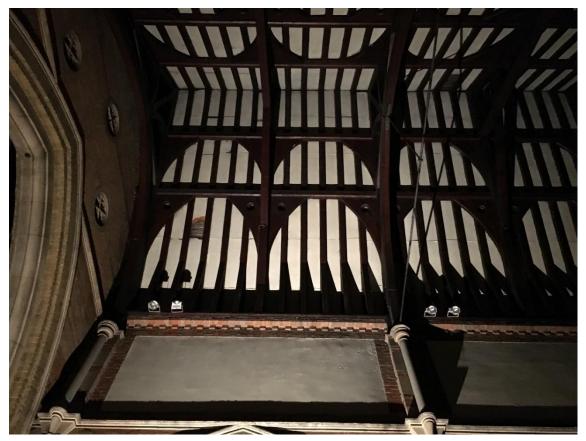
The work at high level in the church is an opportunity to deal with a longstanding and urgent problem with fibreboard panels becoming loose in the church ceiling. These must be inspected and secured. This has been identified as requiring attention within 2 years in the 2018 Quinquennial report. Additional scaffolding is required to get to the fibreboards - included in the estimate for work.

Fibreboard sections (painted white) between Nave roof beams. A broken section can be seen exposing the lathes and some potential slipping at high level.
